Blakemore Cash & Carry, Bangor Preliminary Ecological Assessment

17.01.2019

Preliminary Ecological Assessment

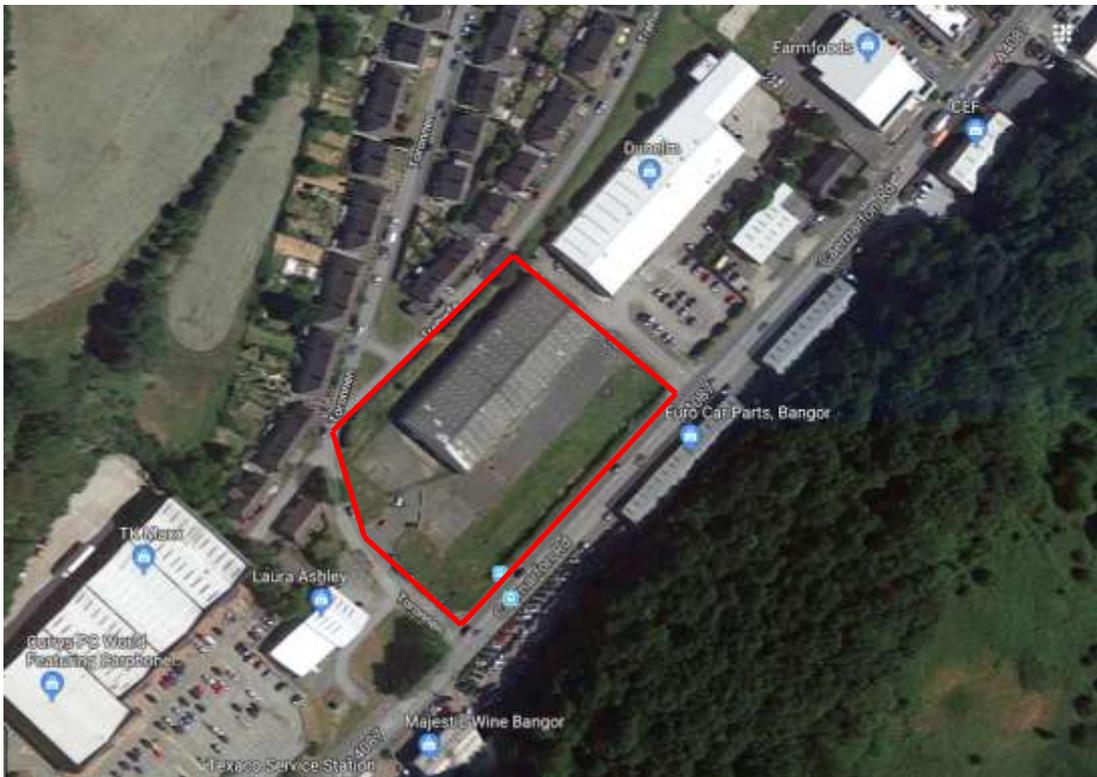
Fig.2: Aerial photo of the former Blakemore Cash & Carry site and surrounding habitat

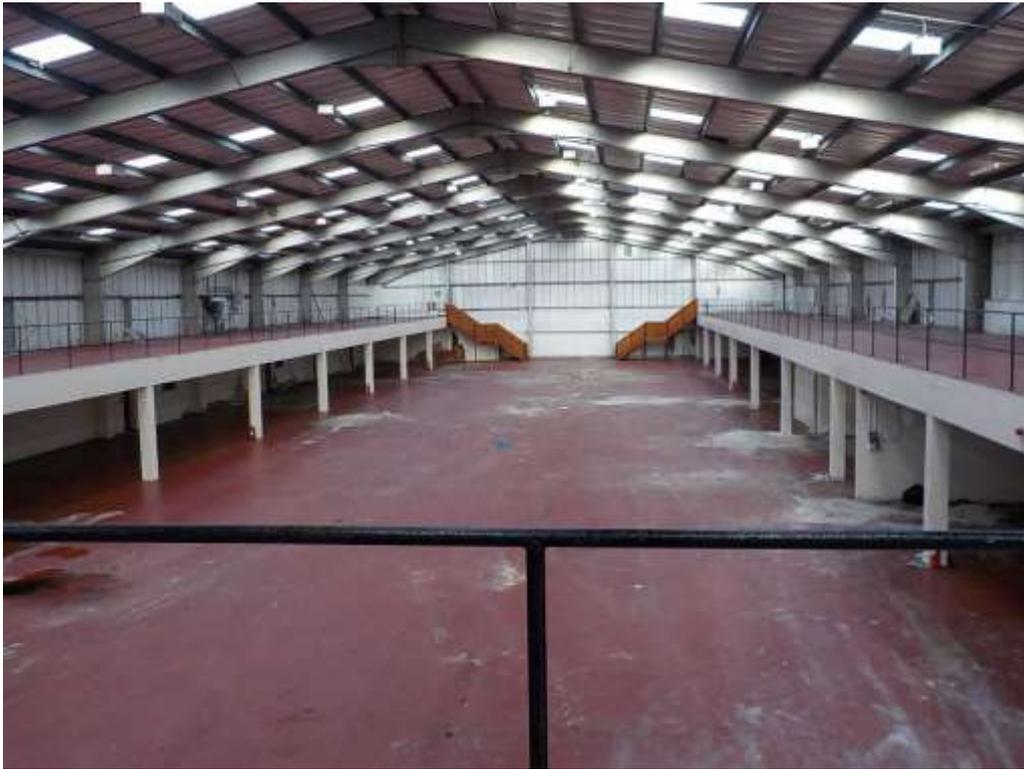
On the interior the building is one large void with no separate roof void. There are no internal or external crevices, no potential bat or bird access to the interior and the exterior is very brightly illuminated on all sides by street and security lighting from the surrounding trading estate.

Interior of the former Blakemore Cash & Carry building

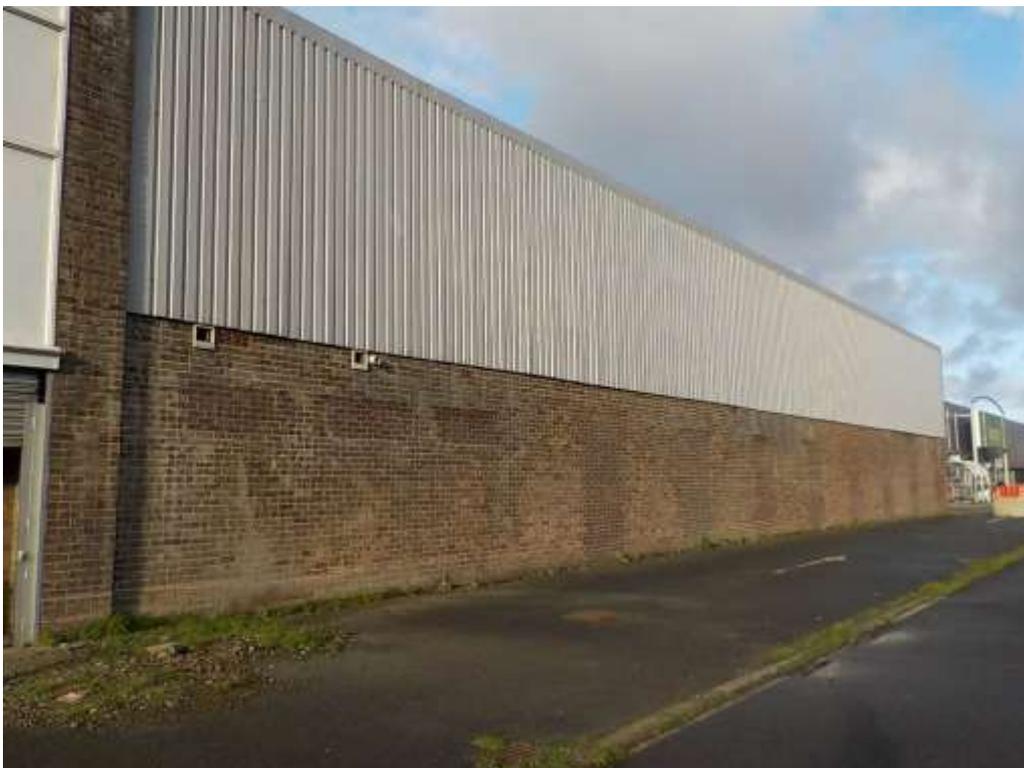
There is one large building on site, the former Blakemore's Cash and Carry warehouse. This is a large, modern structure on a steel frame. The exterior is clad with a combination of concrete block, brick and corrugated steel sheeting. The roof is also corrugated steel sheeting with the addition of some transparent plastic panels.

Front elevation of the building, facing the Caernarfon Road

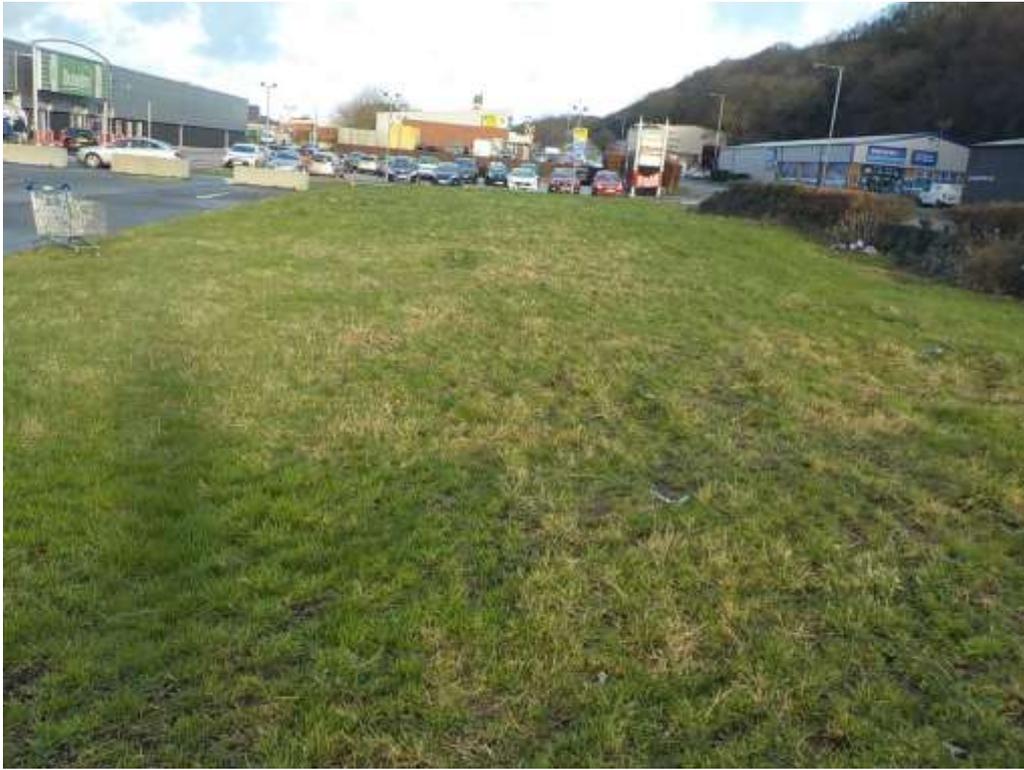
There are two areas of amenity grassland on the site which are managed by regular mowing. As a result, the species assemblage is dominated by plants that can withstand this type of management regime. The broadleaved plant species present include creeping buttercup; (*Ranunculus repens*), dandelion; (*Taraxacum officinale*), broadleaved dock; (*Rumex obtusifolius*), and common sorrel; (*Rumex acetosa*). Perennial rye grass; (*Lolium perenne*) is the dominant grass species with cock's foot; (*Dactylis glomerata*) also present in places.

Amenity grassland to the front of the building

No mitigation measures are required for the potential loss of these habitats.

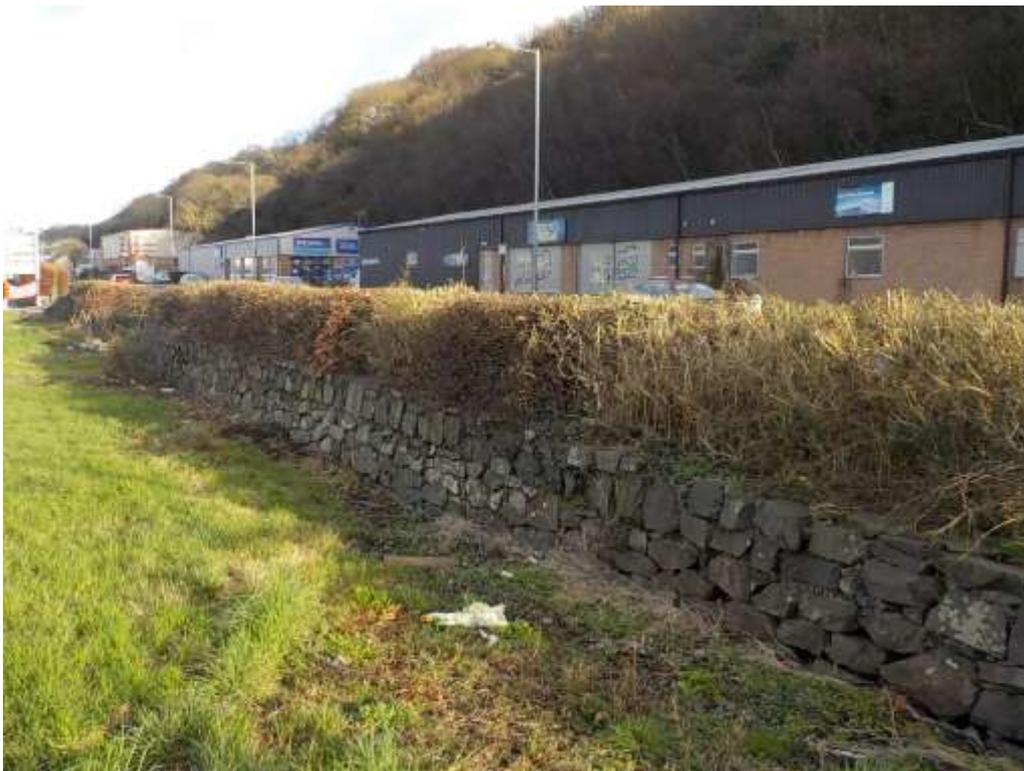
The hedge just outside the boundary with the A4087 is heavily managed and comprises hawthorn, hazel; (*Corylus avellana*), beech; (*Fagus sylvatica*) and ivy; (*Hedera helix*). There is also an ornamental species present in the form of Wilson's honeysuckle; (*Lonicera nitida*), a common garden hedging plant.

Hedgerow growing just outside the stone wall site boundary

It is recommended that the hedges and trees on the site are retained. If this is not possible, native trees/shrubs of benefit to wildlife must be included in the new landscaping scheme.

If any areas of hedgerow are to be cleared or the semi-mature trees felled, then this should be undertaken outside of the nesting bird season (1st March to 30th September). If this is not possible within work schedules, then they must be checked for any active bird nests by an experienced ecologist prior to clearance. In the event of any nesting being recorded, the clearance works must be delayed until such time as any chicks have fledged.

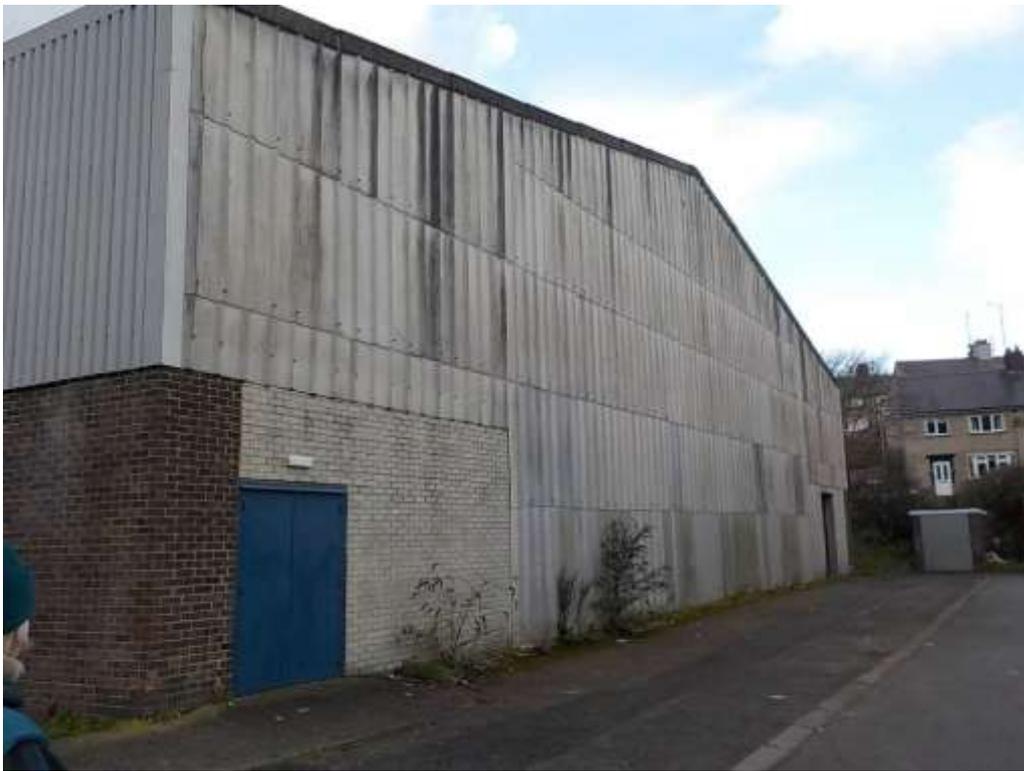
Gable end of the building

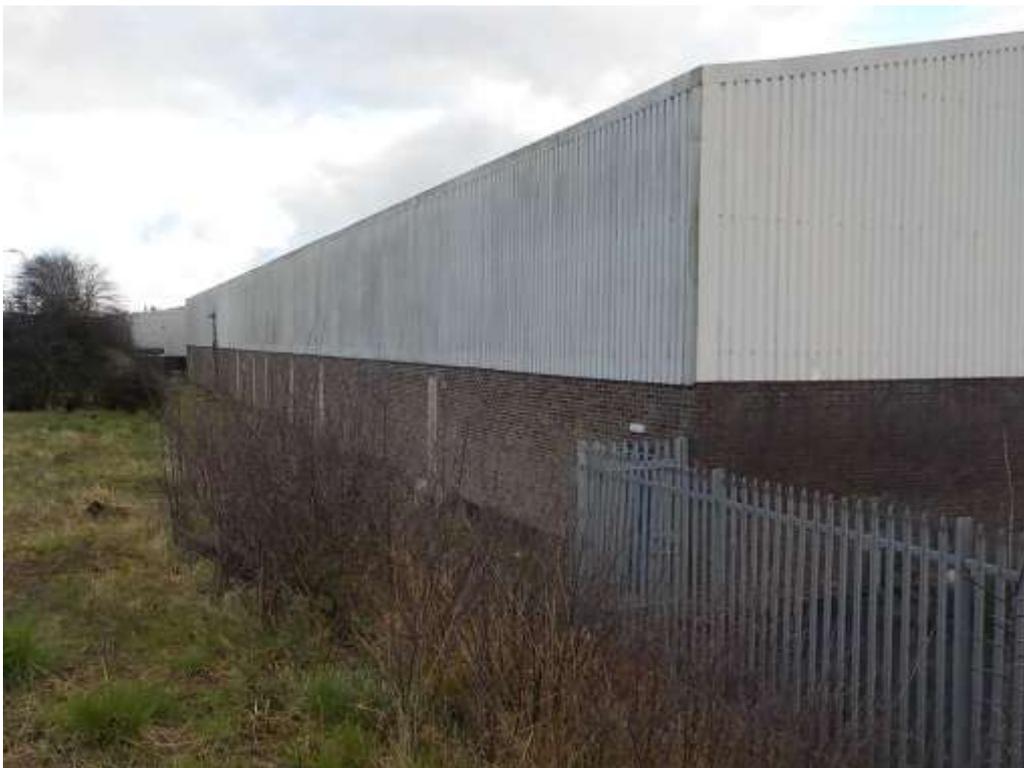
There is a small area of scrub to the rear of the building which is a mono-culture of blackthorn; (*Prunus spinosa*) suckers which appear to have originated from an individual shrub which has since been removed although the stump is still present.

Rear elevation with remaining blackthorn scrub

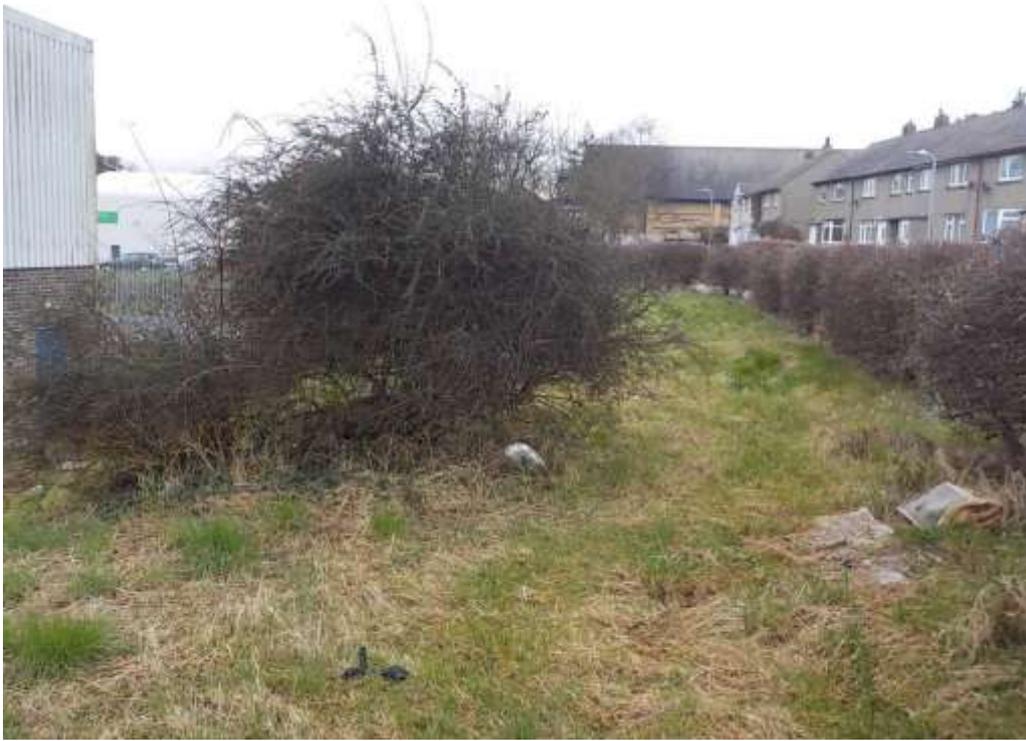
The hedge to the rear of the building is a mono-culture of hawthorn; (*Crataegus monogyna*) and is managed on the top and on the boundary with the road but has been allowed to grow longer on the inside.

There are three trees at the top of the bank to the rear of the building, all of which are Whitebeam; (*Sorbus aria*) a species commonly used in urban planting schemes.

Grass bank to the rear of the building with occasional tree/shrub and hedgerow
